Edwin B. Forsythe
National Wildlife Refuge –
Headquarters
Impoundment
Design/Build Project

Environmental Assessment

U. S. Fish and Wildlife Service

2/4/2016

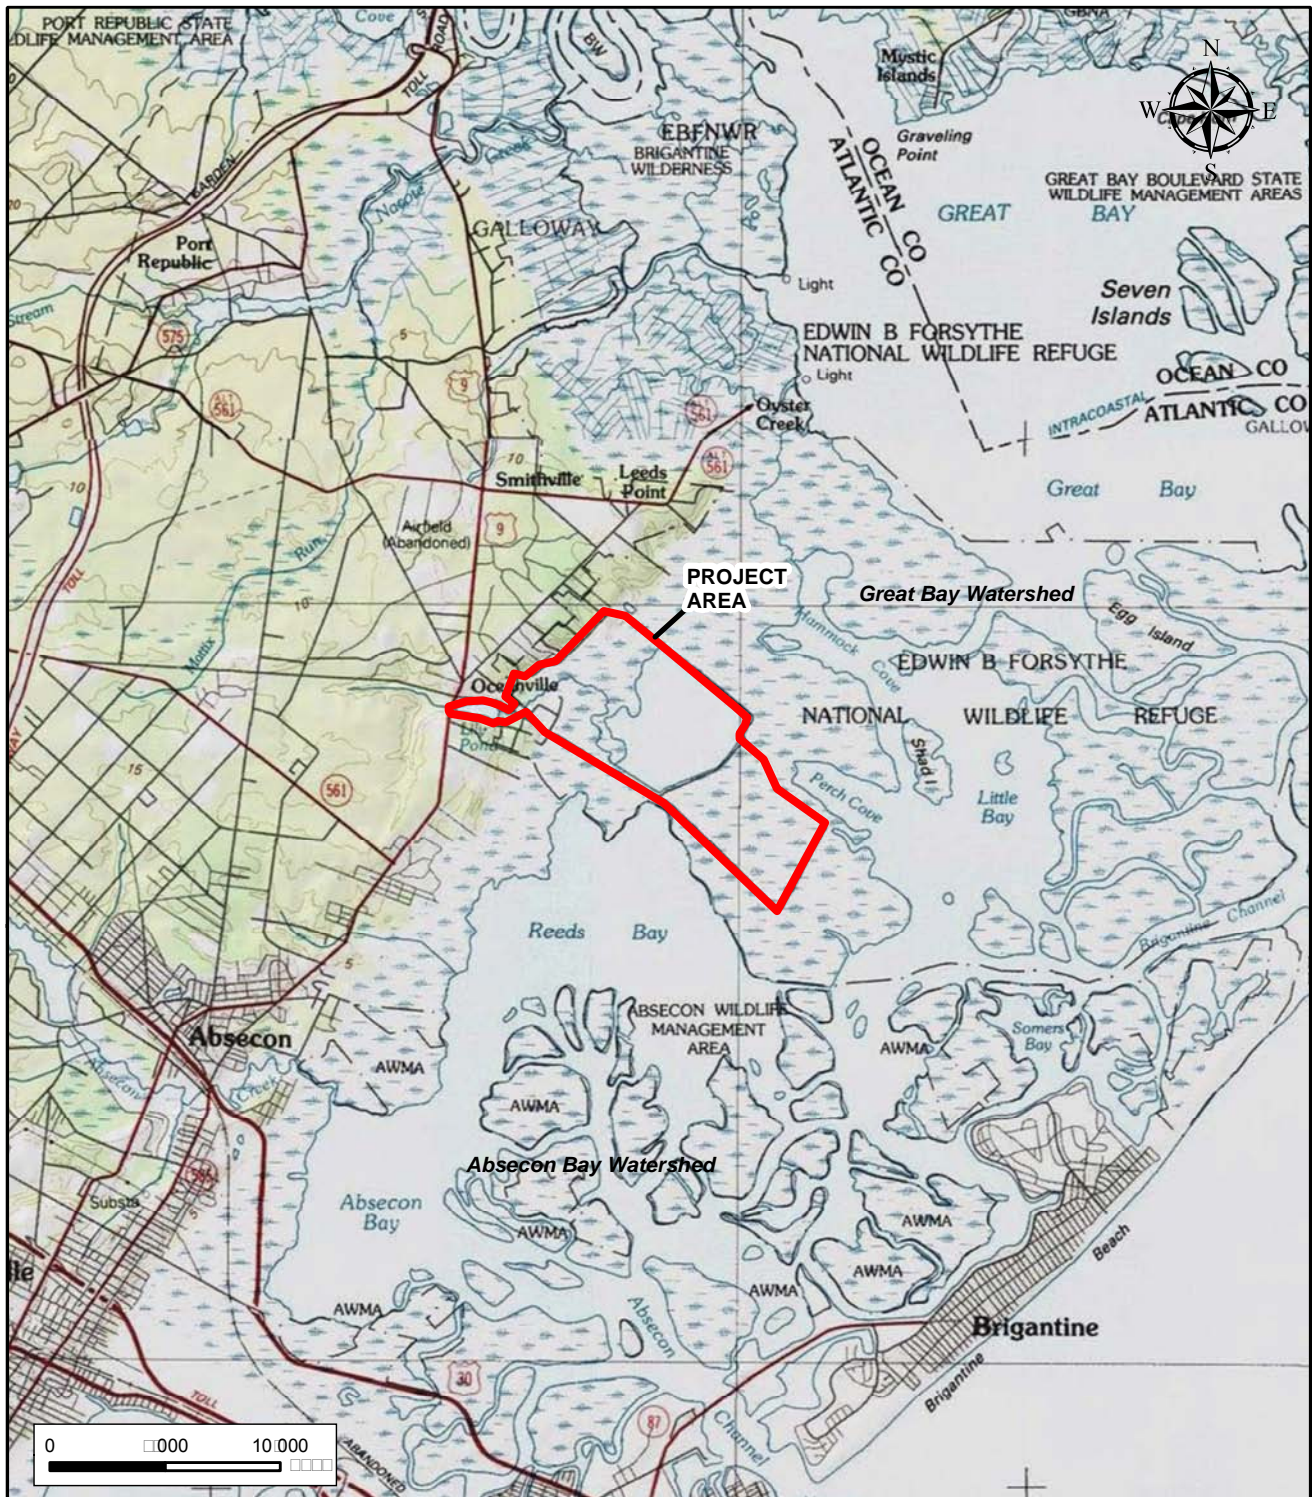
The site is mapped to occur primarily on Transquaking mucky peat, 0-1% slopes, very flooded surficial soils (**Figure 3.2**). The Transquaking series is described by the United States Department of Agriculture (USDA) as very deep, very poorly drained soils, containing organic deposits underlain by loamy mineral sediments and flooded by tidal water. These Euic, mesic Typic Sulfihemists soils are found in brackish, estuarine marshes along tidally-influenced rivers and creeks. The Transquaking Series soils were previously mapped as Tidal Marsh miscellaneous area (USDA 2015).

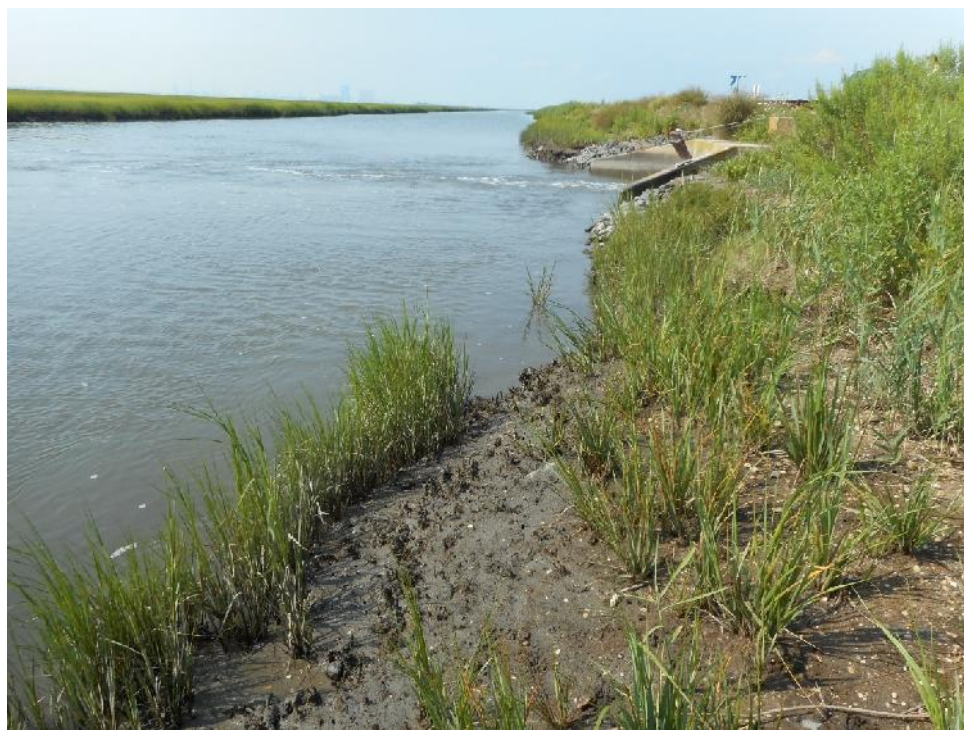
Photo 15

Zoomed-out view of WCS #3 on the bay side, facing southwest.

A third activity includes the replacement of WCS #3. WCS #3 is not functioning appropriately, which precludes the control of water into or out of the eastern impoundment. This failure compromises the ability of the Service to manage the pool in accordance with the management objectives of the refuge. The scour and erosion around this WCS is so significant, it contributed to the increased Priority Ranking Factor value and overall safety classification of “Conditionally Poor” for the Wildlife Drive dike inspection report (SDE 2015).

Because previous attempts to repair erosion and scour at WCS#3 by adding fill and riprap was met with limited or no success, replacement of the structure is required. A new WCS #3 is also necessary to reduce velocities into and out of the East Pool as recommended by SDE 2015. The design of the replacement WCS will be in line with the Service’s decision to maintain the East Pool as a salt marsh community.

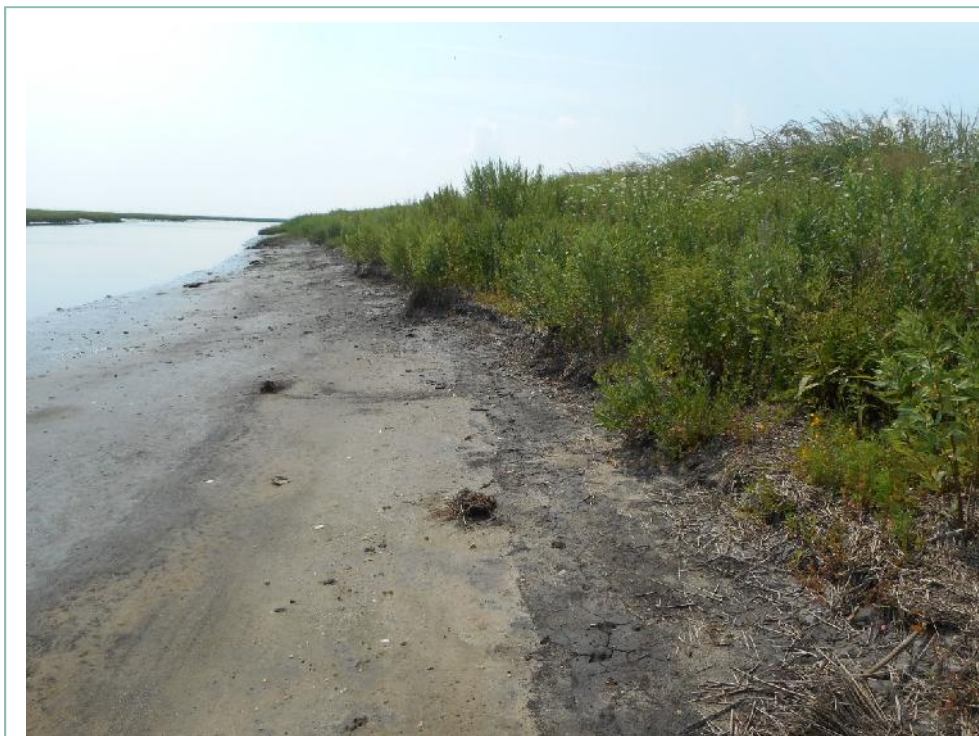
Photo 23

Zoomed-in photo of dog-leg shoreline, facing southeast.

A second action includes the replacement/addition of riprap armoring at two distinct locations along the North and South Dikes to stabilize downstream embankment slopes. The current conditions are such that riprap that was historically placed within the Turtle Cove section of South Dike is no longer effective and the Dogleg portion of North Dike is vulnerable as its slopes have never been stabilized using riprap or other engineering controls. Therefore, these areas are subject

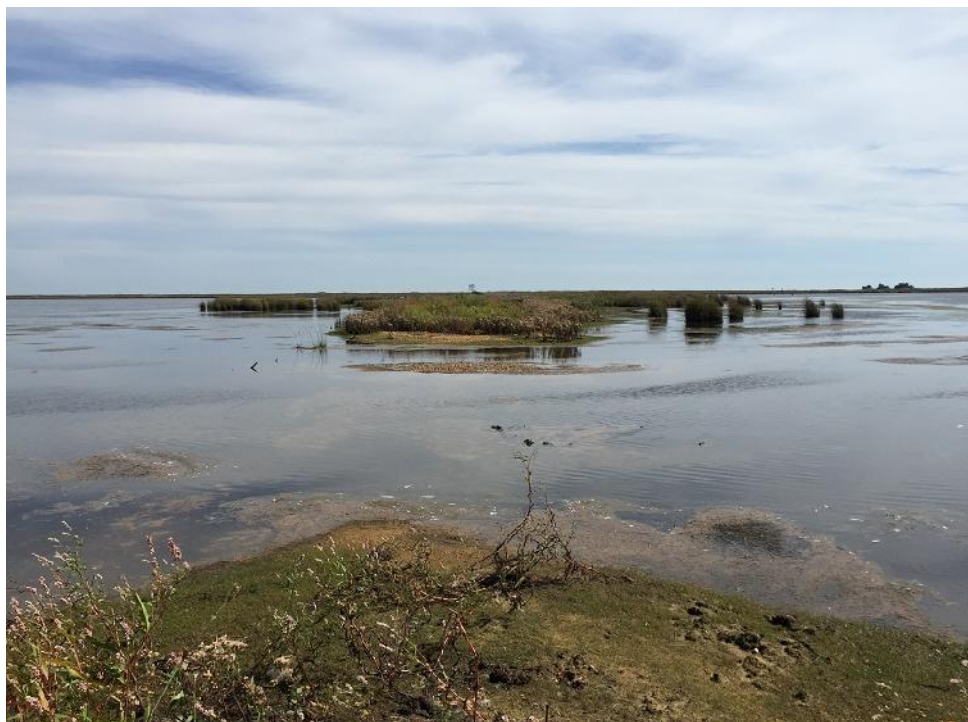
Photo 42

General view of breach in the Long Dike.

A number of individual restoration/construction/management activities are planned as part of the Proposed Action. The first action includes the repairing and filling of the Long Dike breach (the dike separating the two western impoundments), allowing for the more effective management of the western impoundments. The breach of Long Dike has eliminated the ability of the Service to manage the western impoundments as two distinct wetland systems. The breach is actually two separate eroded areas that, when combined, extend 580 feet along the east/central alignment of the dike. Approximately 3,220 additional feet of the dike is eroded and in disrepair, requiring regrading and filling. The repairs to the dike will allow the Service to once again manage the western impoundments as two separate pools.

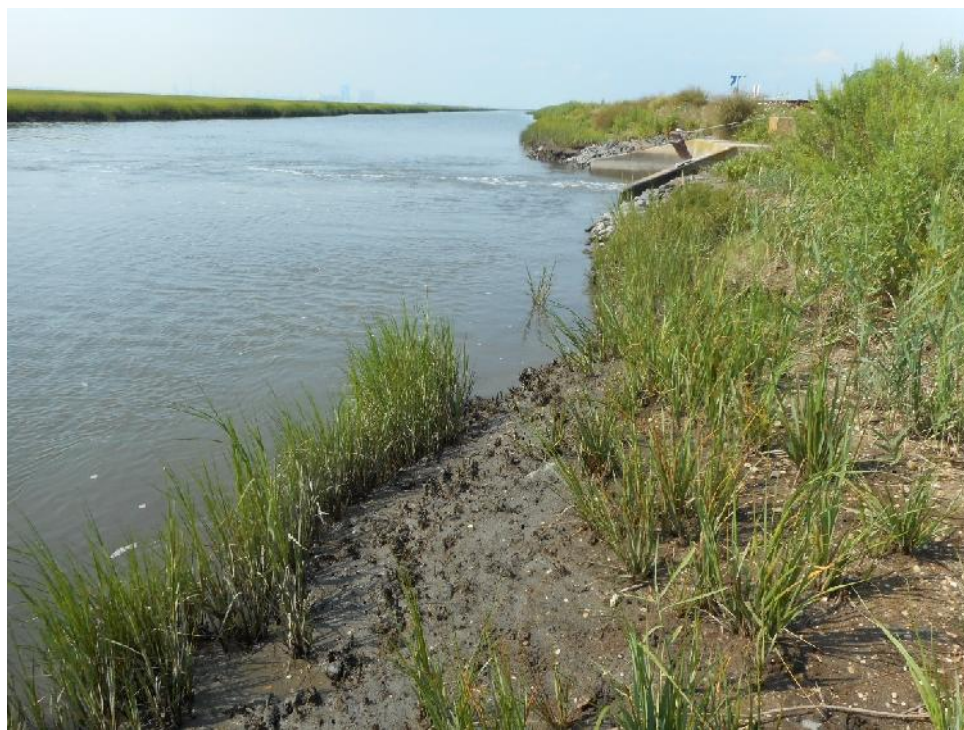
Photo 15

Zoomed-out view of WCS #3 on the bay side, facing southwest.

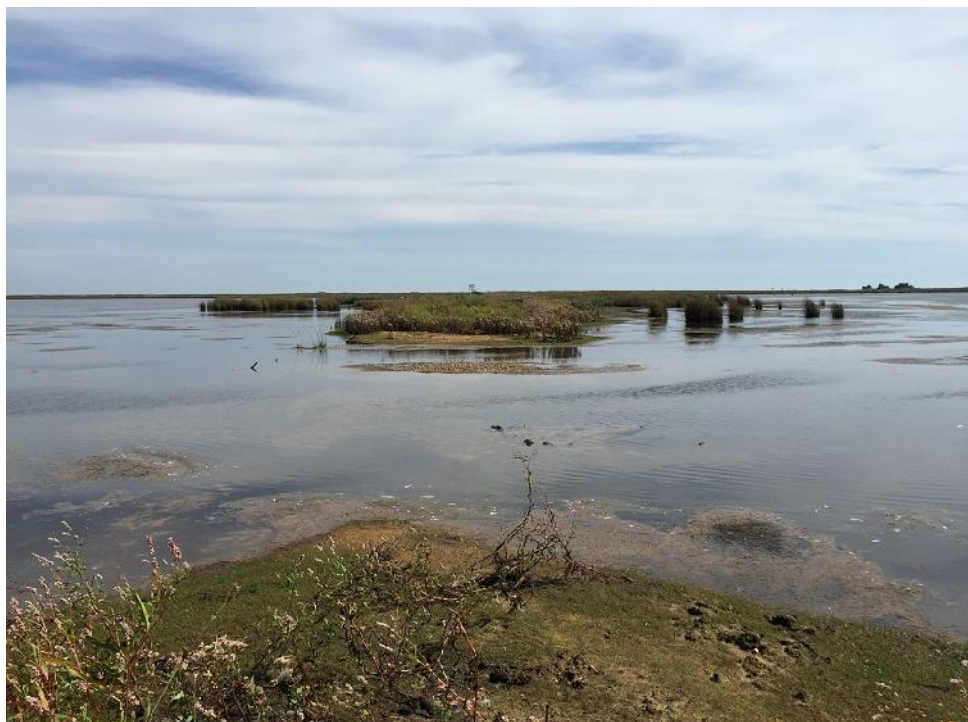
Photo 42

General view of breach in the Long Dike.
